UTILITY PERFORMANCE REPORT FOLLOWING HURRICANE IRENE AND TROPICAL STORM LEE

New York State
Department of Public Service

JUNE 2012

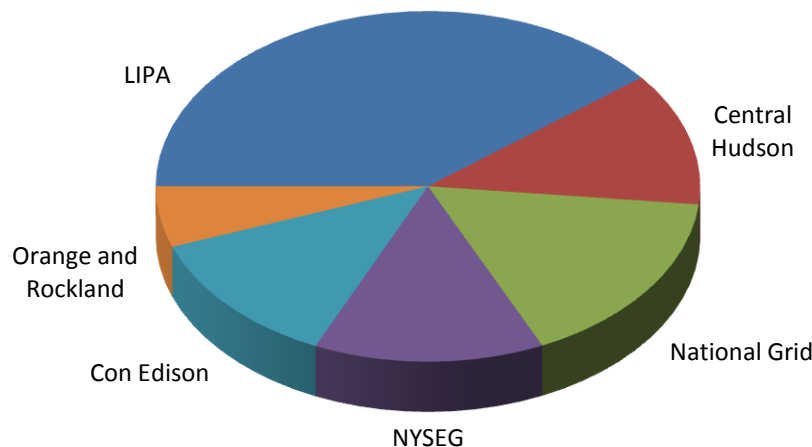
Figure 2: Outage Distribution as of 10:00 p.m., August 28

As the storm moved inland, the number of customer outages upstate continued to climb while the utilities downstate were beginning to restore customers. Continued high winds behind the storm's center caused additional damage. Because a significant number of downstate customers had been restored in the afternoon, the total number of customers statewide without electric service reached a second, lower peak of 950,000 at 10:00 P.M. The distribution of the affected customers at this time, by Company, can be seen in Figure 2 below. This chart represents the overall condition of the electric utilities as the storm system exited the state. Of the total customers without service on Sunday night, over a third are served by LIPA. National Grid had the next highest number of customers affected, followed by Con Edison, NYSEG, Central Hudson, and, Orange and Rockland.

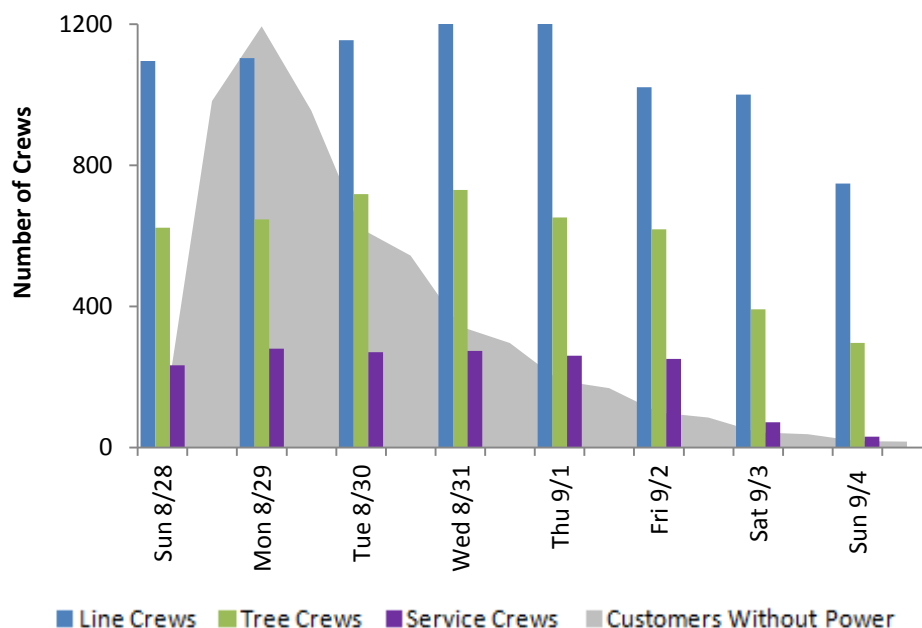
Figure 3: Crew Availability Statewide

From a statewide perspective, Figure 3 shows the hundreds of crews that the New York's investor owned utilities retained to respond to the storm. In the figure, the blue bars represent the total line crews responsible for repairing damage to the electric system. The green bars show the number tree crews used to remove vegetation. The grey area in the background indicates the relative number of customers without power. The utilities continued to obtain crews as they became available through mutual assistance groups and other outside resources. The total number of line crews reached its maximum on Wednesday, August 31, four days into the storm.

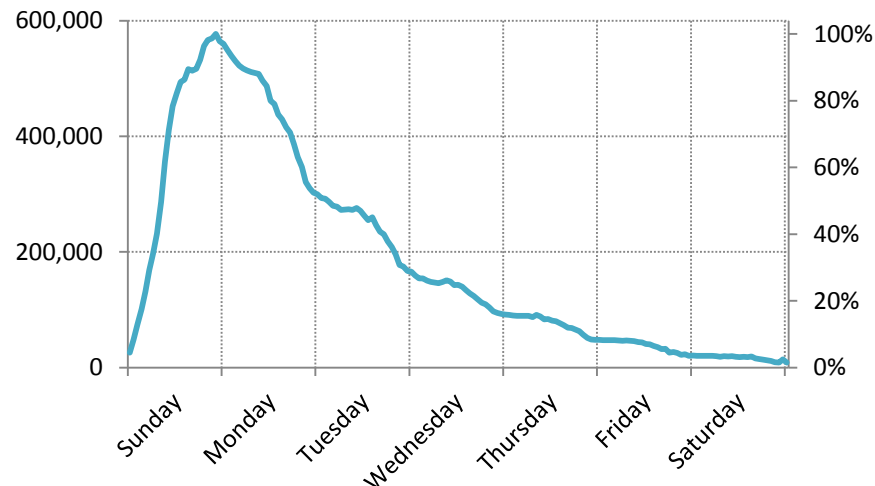
Figure 4: Customer Outages (Investor Owned Utilities)

In this instance, full scale customer restoration began on Monday, August 29 for all the utilities. Figure 4 illustrates the rate of restoration throughout the state for the investor owned utilities, combined. The line has a steep decline soon after the storm, showing that the most rapid rate of restoration was occurring. The line flattens out with time because it takes longer to restore power in heavily damaged areas and
